This safety alert is drawn up to spread the lessons learnt from the major oil release of October 25th, 2005 in an oil storage terminal. The oil storage terminal belongs to a large oil company and is an upper tier Seveso establishment.

This alert is based on the investigation of the company, for which several external experts were consulted, and the investigation of the Belgian authorities. After the accident history recommendations are formulated to prevent similar accidents in the future.

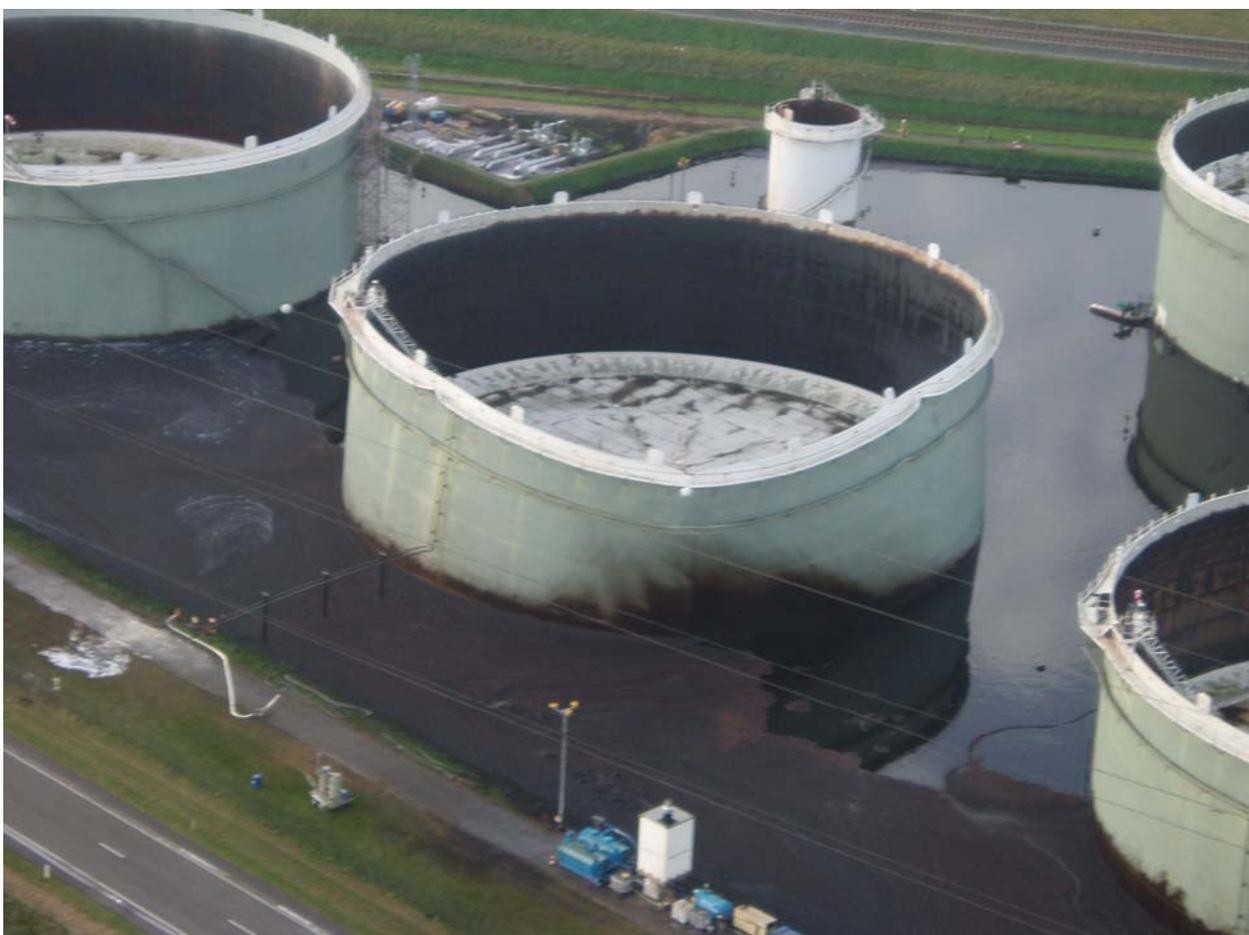
Because the content of the storage tank was released in such a short time, an enormous wave was created. This wave moved in the direction of the several meters high earth dike. Due to the height of the dike only a small amount of crude oil (approximately 3 m³) was ejected out of the bund. The released crude oil filled the whole bund (40 000 m² large) with crude up to a height of 1 m.

Figure 2: Picture of the situation in the bund the morning after the major accident

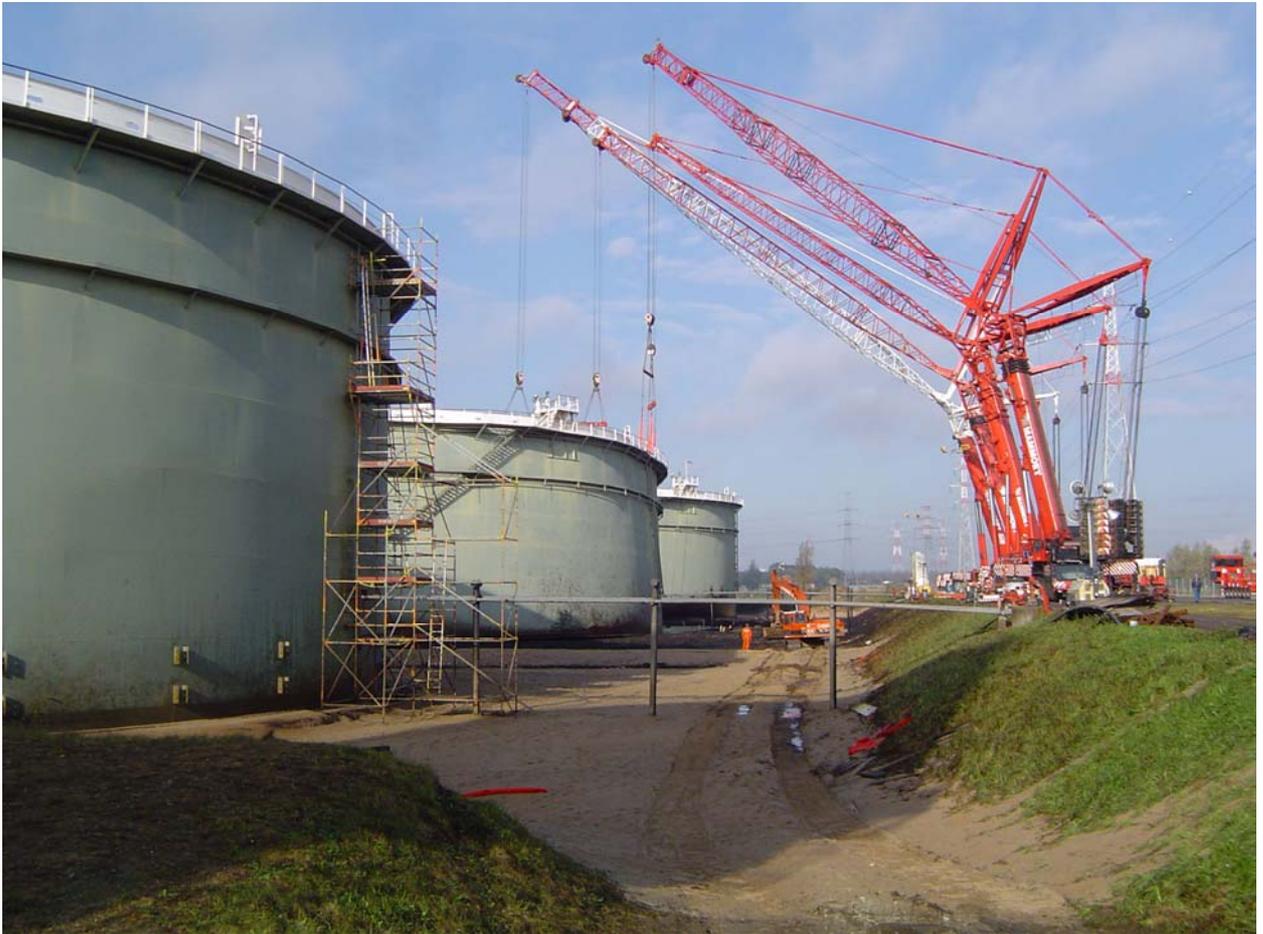
After the release the storage tank was leaning forward and a part of the foundation of the storage tank had disappeared.

The stability of all storage tanks was periodically measured. The stability of storage tank D2 on the place where the foundation was blown away, was achieved by hanging the storage tank on 4 large cranes (figure 3).

Figure 3: Picture of major cranes stabilising storage tank D2

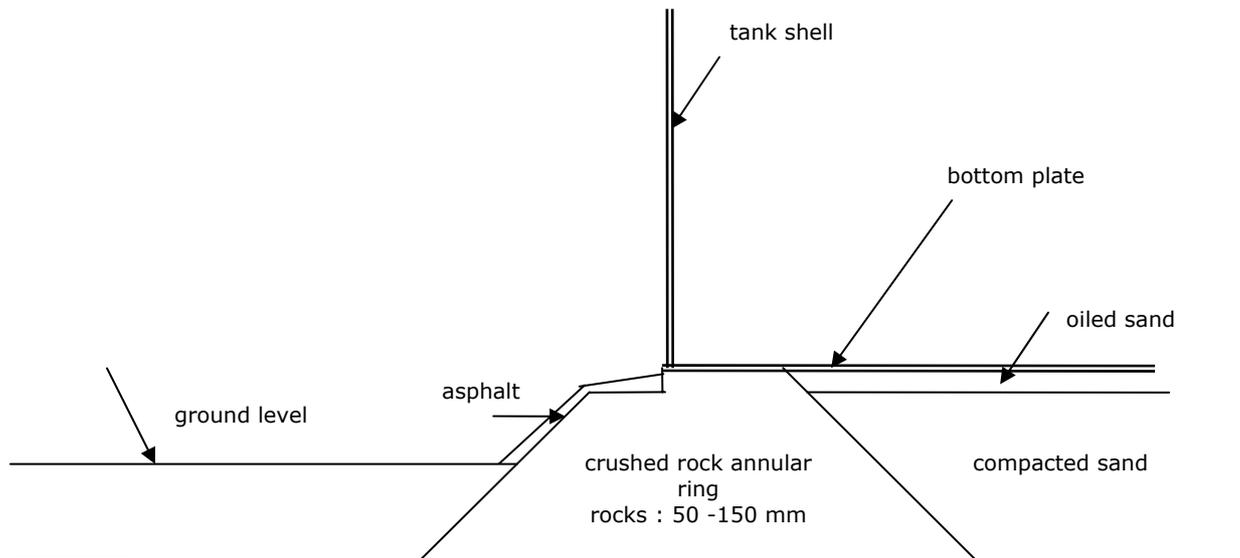
Figure 4: Schematic view of the tank foundation

The foundation of storage tank D2 consisted of a crushed rock annular ring. The rocks had a diameter between 50 mm and 150 mm. The crushed rock annular ring had a height of approximately 120 cm of which a part was below the ground level. The crushed rock ring had a width of approximately 340 cm at the bottom and 100 cm at the top. The shell was situated in the middle of the width of the crushed rock ring. The inner part of the annular ring was filled with compacted sand. Above this sand there was a layer of 5 cm consisting of oiled sand, to avoid external bottom corrosion. Figure 4 provides a schematic view of the foundation of storage tank D2.

As mentioned before, a gutter was situated in the tank bottom at a distance of 1,5 m from the tank wall. This is just beyond the annular plates on which the tank shell is welded. The first normal bottom plates after the annular plates have been teared during the accident. The gutter has been formed due to settlements in the tank foundation, which at that place consists of compacted sand. The gutter has probably been formed during the first hydrostatic tests on the storage tank. The moment a storage tank is loaded for the first time, the compacted sand settles. In the neighbourhood of the crushed rock annular ring, which consists of coarse rocks, it is difficult to compact the sand bed in an appropriate manner during construction. At the moment the storage tank is loaded for the first time, the sand in that area will be more compacted, but because of the existing holes in de crushed rock annular ring a part of the sand will disappear in the holes between the coarse rocks. Due to these phenomena a gutter is formed in the bottom plates nearby the crushed rock annular ring. Calculations based on a finite element method showed that based on the information about the foundation of the tank in combination with the underground under the tank foundation and the size of the storage tank, the forming of the gutter could be predicted.

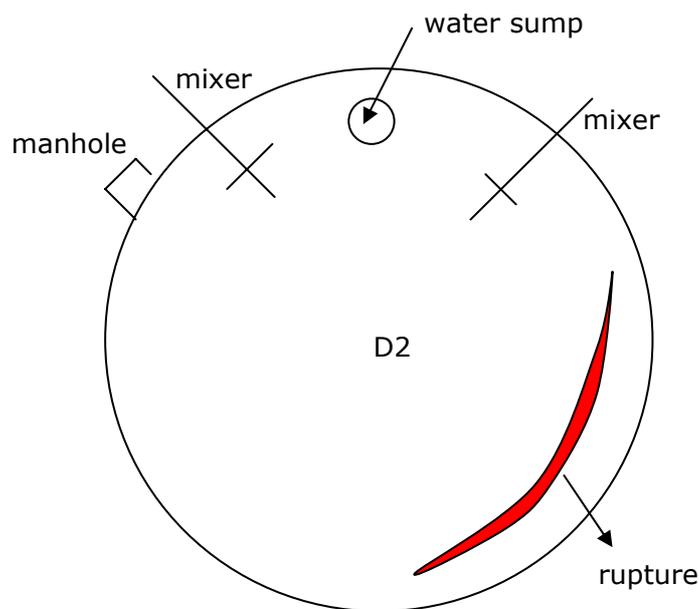
Figure 5 : Schematic view of the bottom of storage tank D2

The investigation of tank D2 showed that the bottom plates in a long, small circular band at approximately 1,5 m from the shell of the storage tank were extremely weakened due to internal corrosion. In this band the thickness of the bottom plates was nearly reduced to zero. This band had a length of approximately 35 m and a width of approximately 20 cm.

In this band the bottom of the tank formed a gutter. In this gutter uniform, internal corrosion was found and no pitting corrosion.

During the exploitation of storage tank D2 a gutter was formed in the bottom of the tank. This gutter is situated at a distance of 1,5 m from the tank shell. Due to the formation of the gutter the present water could not longer flow to the drain water system to be removed. The accumulation of stagnant water in the gutter caused strong corrosion which strongly reduced the thickness of the bottom plates in that area.

In the gutter in the bottom of the tank, the present water could not longer flow towards the water sump. This situation of stagnant water in the gutter enabled very fast corrosion in the gutter with the rupture of the tank bottom as the major consequence.

The parts of the bottom plates of the other storage tanks of which the thickness and/or the deformation do not fulfil the prescriptions of API 653 shall be repaired. The foundation of the other storage tanks was investigated to control if they still have enough stability (during the accident they were drawn in crude oil) to restart the exploitation of the storage tanks.

Before start-up all crude oil storage tanks shall be coated with a lining to stop the internal corrosion of the bottom plates.
