Major accidents related to ageing

The aim of the bulletin is to provide insights on lessons learned from accident reported in the European Major Accident Reporting System (eMARS) and other accident sources for both industry operators and government regulators. In future the CAPP Lessons Learned Bulletin will be produced on a semi-annual basis. Each issue of the Bulletin focuses on a particular theme.

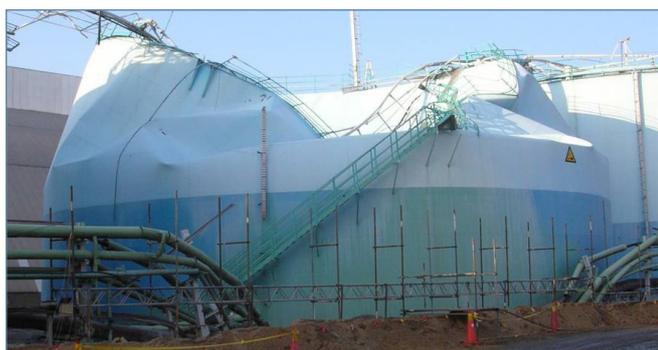
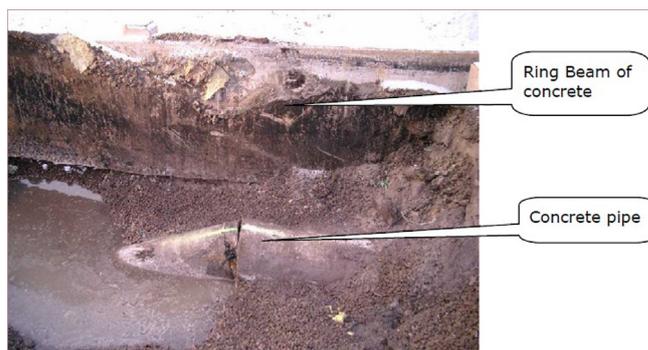
The cause of this incident was a leak in an underground coolant supply pipe of reinforced concrete installed over forty years before that resulted in a weakening of the ground under the tank farm. Apparently, water forced its way out of the pipe, eroding the ground near and around the sulphuric acid tank. This erosion damaged the ground under the tank which ultimately failed due to the lack of support of the tank floor. A study of the appearance of the involved part of the coolant supply pipe suggests that the corrosion was a result of an acidic attack on the concrete.

- The pipe had been in use over many years and the operator had no suspicion that the pipe was suffering severe degradation. The inspection of the failed pipe after the incident detected little or no internal corrosion, but heavy external corrosion to the concrete. In certain places the concrete had corroded so severely that the reinforcing steel was exposed.

- The uneven corrosion on the outside of the pipe can possibly be explained by the fact that it lay partly in groundwater flow. In this environment, the acid can pass through the barrier more easily, and the reaction products (gypsum) formed can be more easily dissolved. As such, the concrete barrier was not as effective as on the part of the pipe that remained in drier surroundings. Therefore, concrete piping exposed to ground water should be subject to protective measures, monitoring and inspection to take into consideration the increased risk from groundwater exposure.

Figures 1 and 2: The damaged tank and underground pipeline (Source: Swedish Investigation Board report).

- Similarly, underground piping that entail risks to foundations should be inspected and measured.
- There are a number of strategies that can be applied to piping where there is accelerated potential for degradation or where there are high consequences should significant degradation occur. Pipes may, for example, be tested for stability (remains in place) and hydraulically checked on a regular basis. Alternatively, consideration should be given to positioning the pipe above ground. The pipe could also be placed in casings, especially where a leak may cause damage to the surroundings or where pressure and ground deformation may cause damage to the pipe.

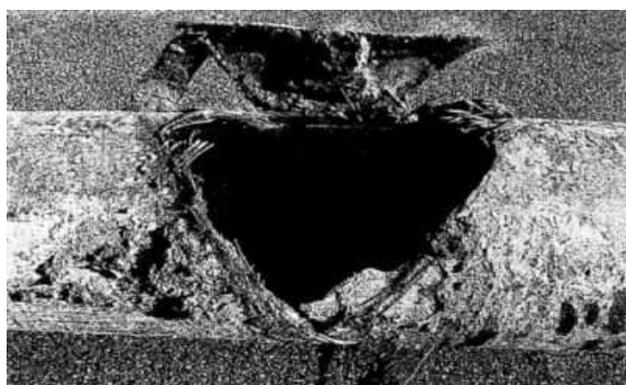
Figure 5: The damaged pipeline (Source: ARIA No. 23562)

Deterioration of the infrastructure was due to a corrosion mechanism occurring in an acid-stressed environment. A number of factors contributed to this accident. One factor is ageing. The corrosion of the pipe material caused an effective loss of strength. In addition, the process design did not adequately address the pressure surge that could occur when the pump is shutdown, in particular, insufficient number of vents made difficult to cope with this situation that is a routine part of the process. Furthermore, there was a failure in installation because of incorrect setting of the surge chamber pressure.

- Leaks were primarily noticed adjacent to pipe elbows and during directional changes. The pressure never exceeded 5 bar vs. a 10-bar design pressure, in a diluted sulphuric acid medium with a temperature below 35°C. The maximum temperature allowed for GRP tubes was 50°C. Therefore, the fact that failures occurred near or at high points and near a change in direction, confirms the role played by hydraulic transitions.

- It was demonstrated that the damage to the pipe was due to a mechanism of stress corrosion in an acid environment. Stress corrosion is a fissuring mechanism that requires a combination of three factors, such as stress or permanent distortion, the material sensitive to the phenomenon and a corrosive environment.

- There was a design problem in this case, due to the insufficient number of vents available to cope with the pressure surge. This is a phenomenon that generally occurs in long pipelines; key factors are fluid velocity, pipeline and rate of valve closure, or in this case, pump shutdown. It can cause a very high pressure surge which travels along the pipe at the speed of sound in the fluid. The vents are provided to alleviate this surge as was the surge chamber - this to minimize any low pressure surge as the pump is shut down.

- Although the pipes and their assembly complied with the provisions in the regulations as required by the project service order, the installation of the pipe and pressure control systems were not in accordance with good custom and practice. In particular, they were not compliant with the original installation specification, sizing of the buffer chamber and calculation of the number of vents required.

- The operator exchanged the NB 300mm pipeline that conveyed acid water to the wastewater facility with a GRP NB 400mm pipeline. Modifications to the process plant, either in equipment itself or in its connections, in instrumentation, in chemicals, or in process conditions can affect the design integrity and bring about additional risks. Normally, a management of change procedure should be conducted to ensure that changes are properly reviewed and approved prior to implementation.

- Even without the mistakes in design and installation, corrosion of critical components of the equipment would ultimately have led to failure, and therefore, should be subject to a systematic inspection program similar to all safety critical elements.
